Polymer Matrix Composite Lines and Ducts

(National Research Announcement 8-21 Final Report)

A. T. Nettles

Marshall Space Flight Center, Marshall Space Flight Center, Alabama

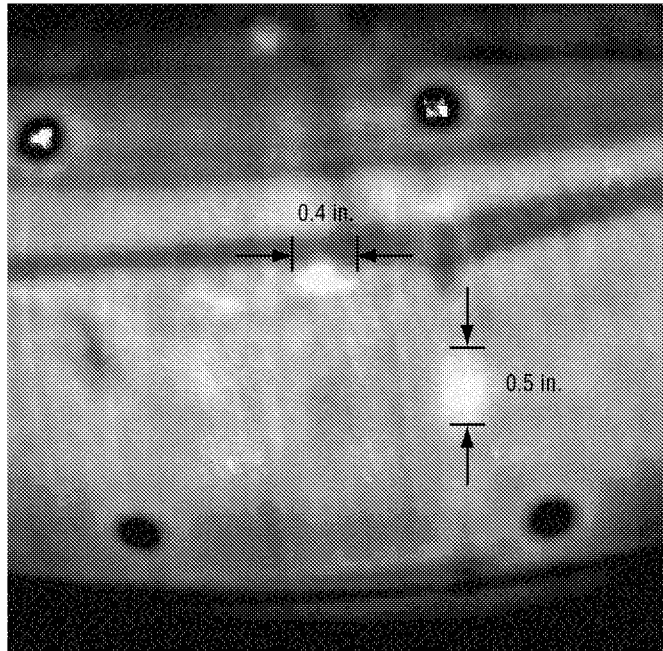
Figure 22b. No surface features. Unknown source.

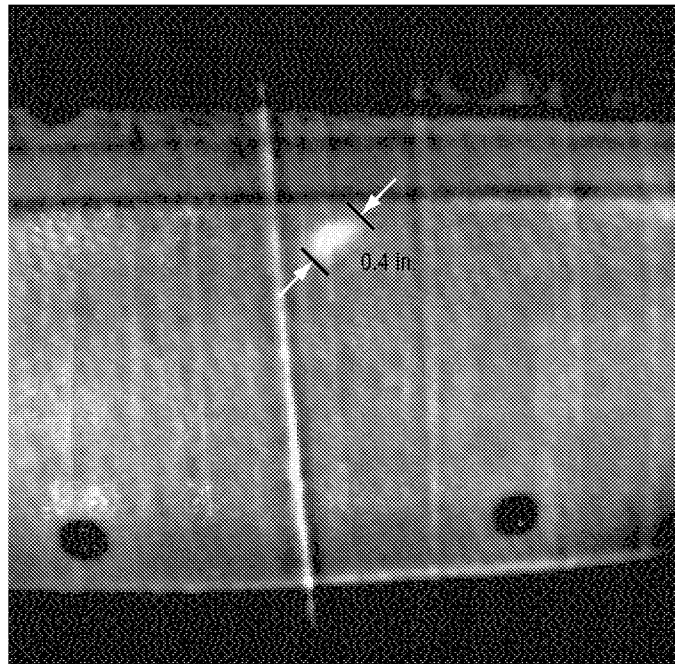
Figure 22c. No surface features but strong thermal indication.
The blurred edges may indicate that this is a delamination from impact.

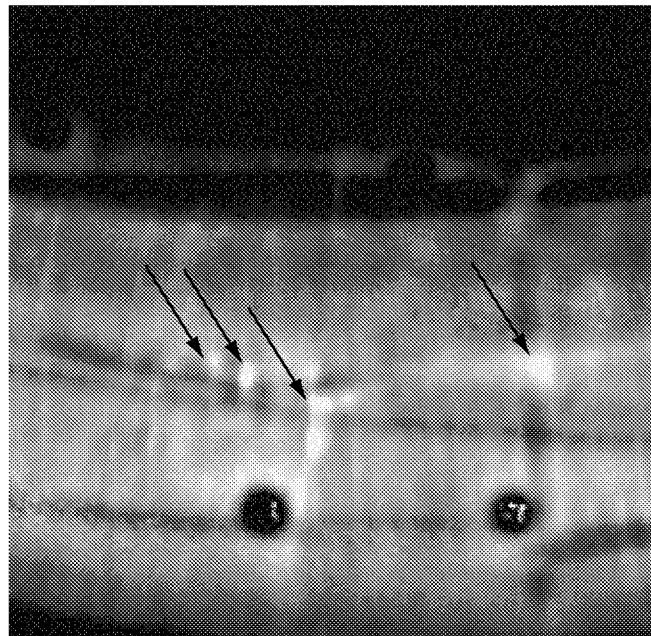
Figure 22e. The surface of the tube shows signs of overworking during fabrication. These regions may be thin, resin-starved zones (indicated by the arrows).

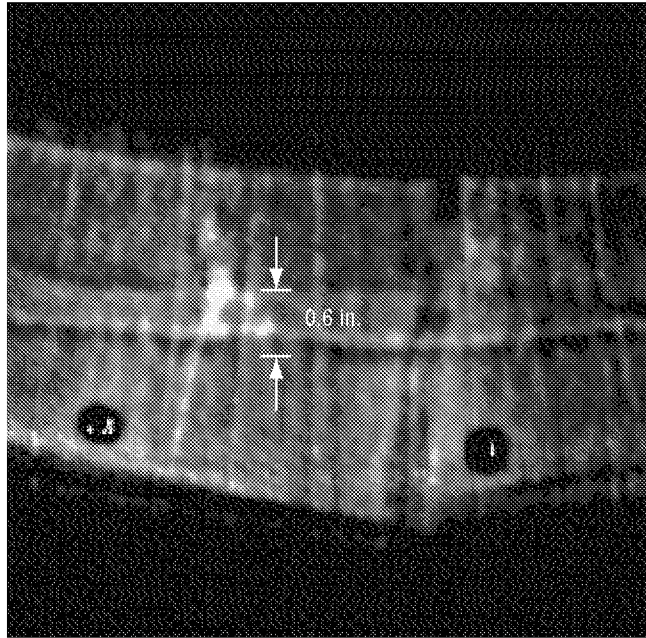
Figure 22f. The surface of the tube has a small bump, which would indicate an inclusion.

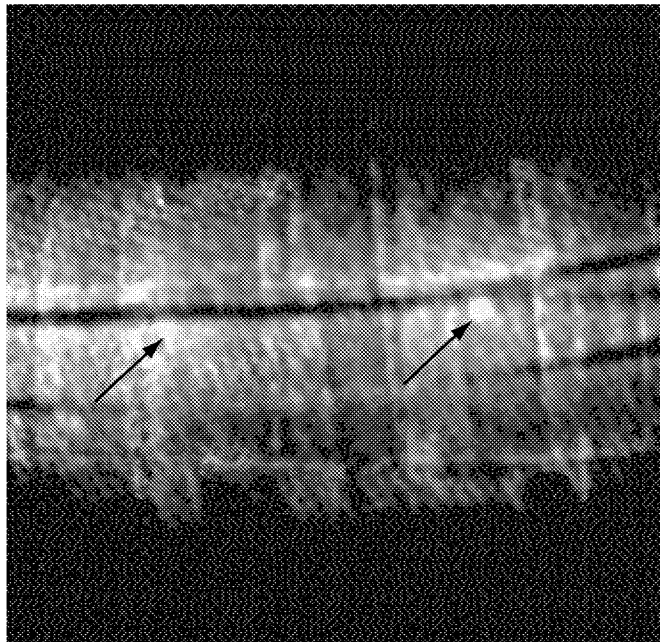
Figure 22g. Possible voids along a seam.

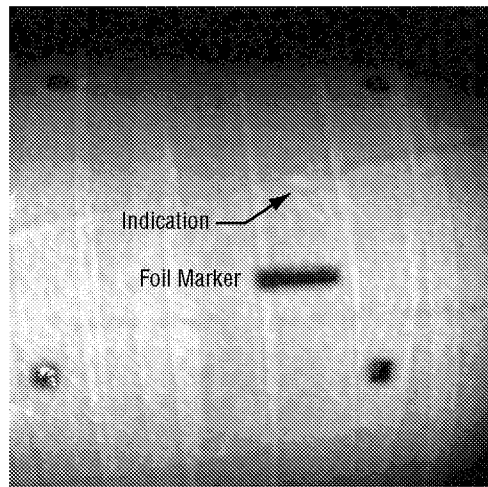
F3

On feedline HLU-8, three small thermal abnormalities were detected as shown in figure 26. The size of each indication was <0.25 by 0.5 in. At region A3, the indication correlates with a surface crack. At position F3, the indication appears to be within the laminate. At position B12, the indication is visible on the surface as a scratch.

Figure 26. Anomalies in feedline HLU-8 (continued).

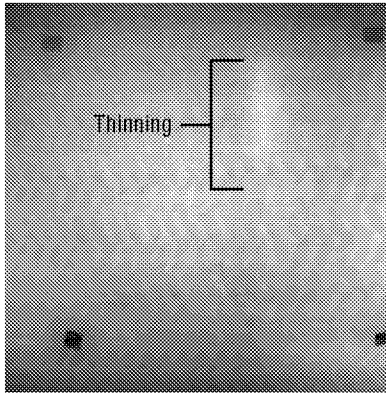
Feedline SARTM-3 showed the same type of thinning at the same location as feedline SARTM-2. A thermograph is presented in figure 28.

Figure 28. Thermograph of thinning in feedline SARTM-3.

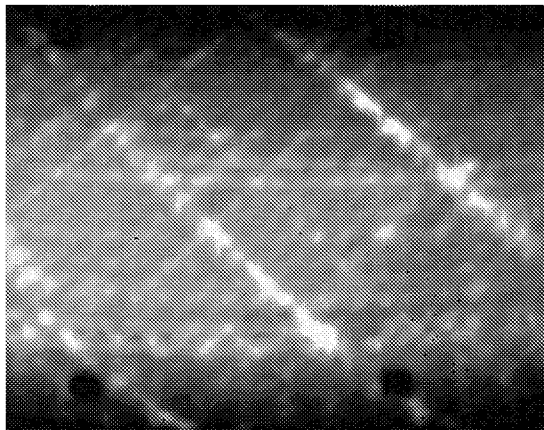
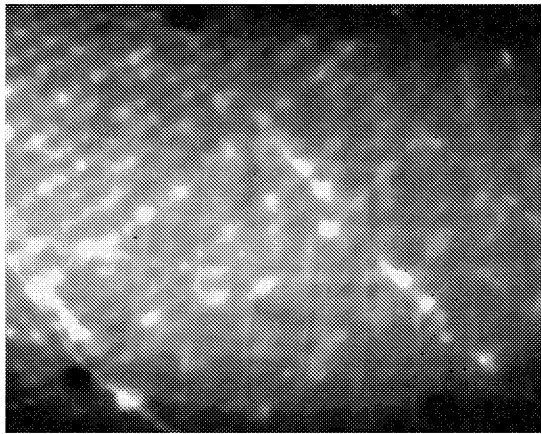
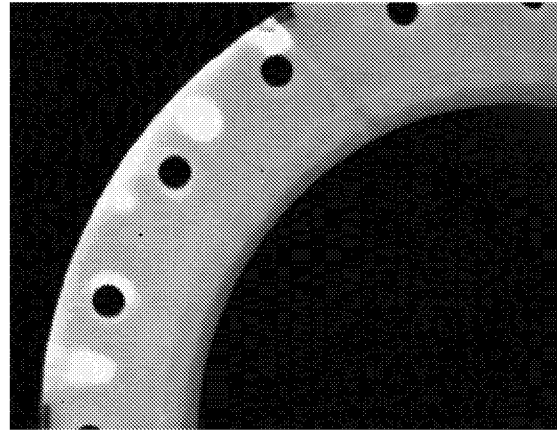
Four feedlines manufactured via TTL were inspected using flash thermography. For feedline TTL-1, the acreage of the tube appears to have many highly porous/low consolidation regions as indicated by the many bright patches in the images. The bright regions in the flange thermograms coincide with missing plies on its back surface. The fillet also shows many low consolidation/highly porous regions. Sample thermograms showing these voids are given in figure 29.

Figure 29. Sample thermograms from feedline TTL-1 showing regions where the tape was not well consolidated in acreage and voids in flanges.

Figure 29. Sample thermograms from feedline TTL-1 showing regions where the tape was not well consolidated in acreage and voids in flanges (continued).

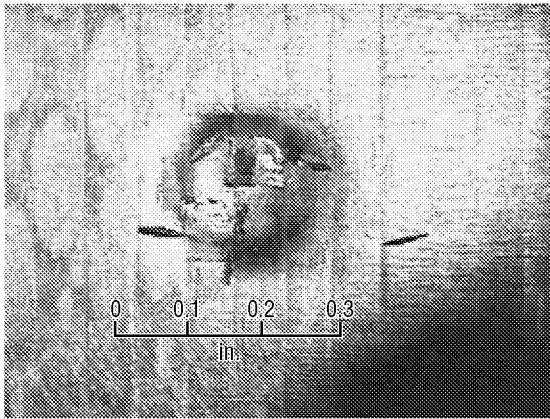
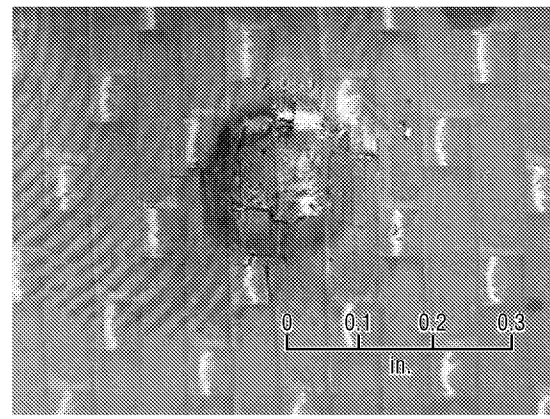
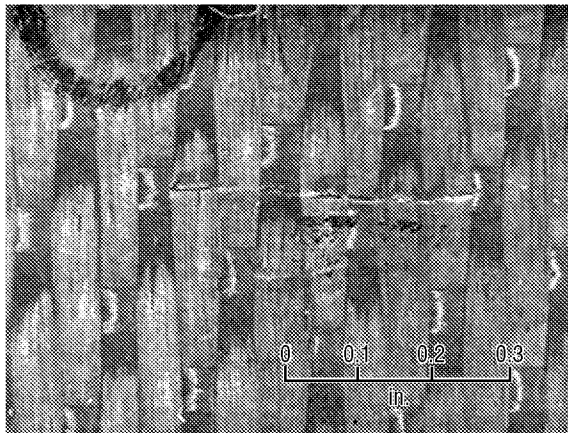
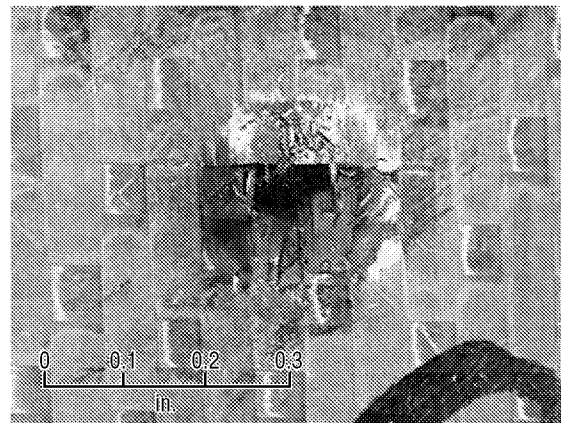
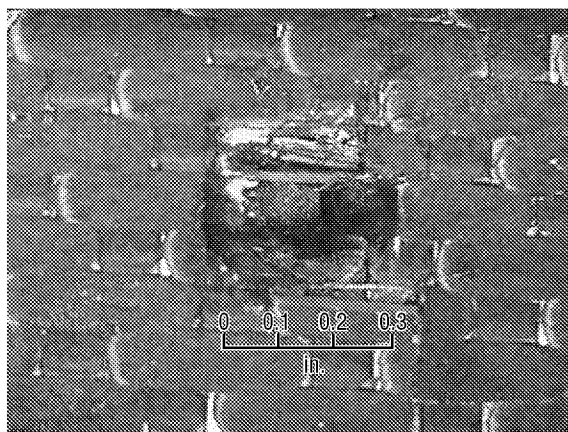
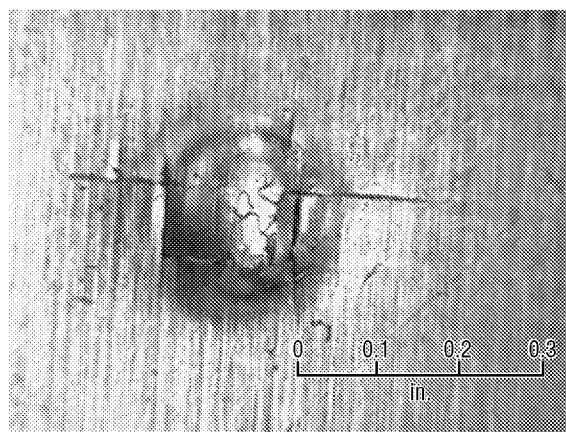
Figure 44 shows the impacted side of each specimen tested at the high (2.5 ft-lb) energy level. In all cases, except the 977-6 resin, a distinct dent is seen in each of the specimens. Fiber breakage is observed in all of the specimens. The 977-6 resin possesses a relatively long crack across the outer warp fibers that span the distance of the impacted zone. The PR 520 has short cracks at or near the indentation formed, as does the PEEK. The remaining three have fiber breakage within the indentation.

Figure 44. Typical damage to impacted side of specimens at 2.5 ft-lb.

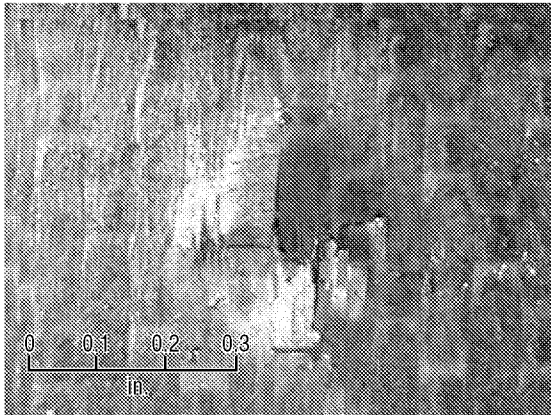
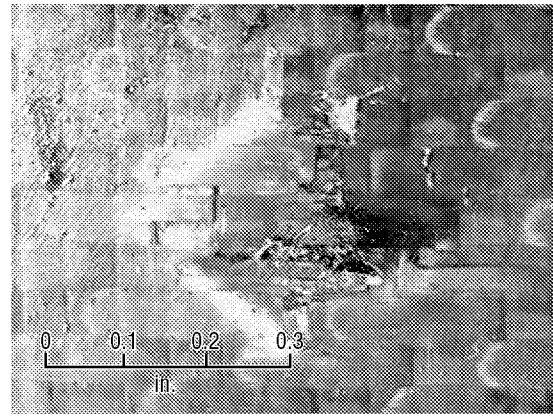
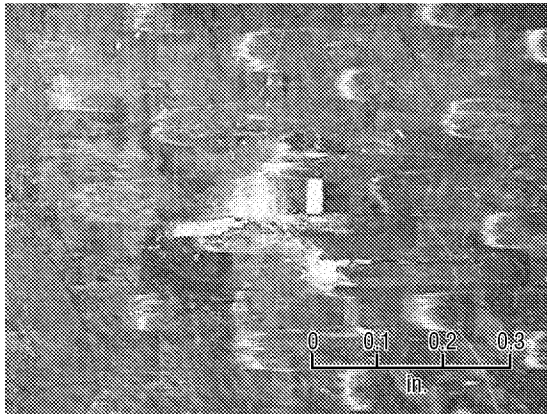
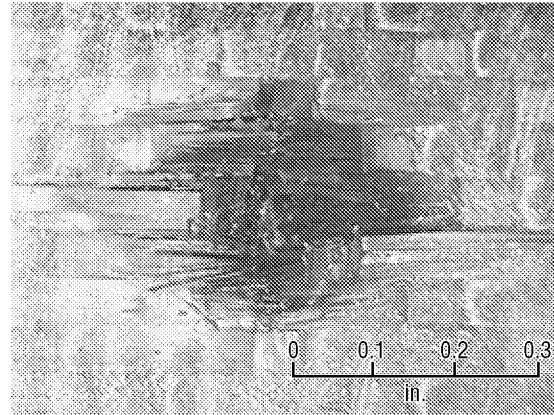
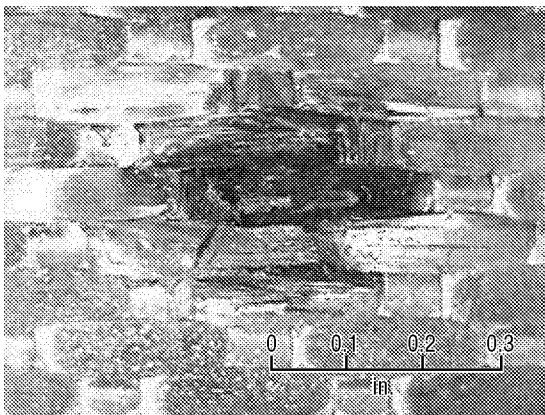
Figure 45 shows the back (nonimpacted) side of each type of specimen tested at the high (2.5 ft-lb) energy level. All samples show backface fiber breakage of varying magnitudes. The 977-2 is the least severe while the RS-E3 and Cycom 823 are the most severe where it appears near penetration occurred.

Figure 45. Typical damage to nonimpacted side of specimens at 2.5 ft-lb.

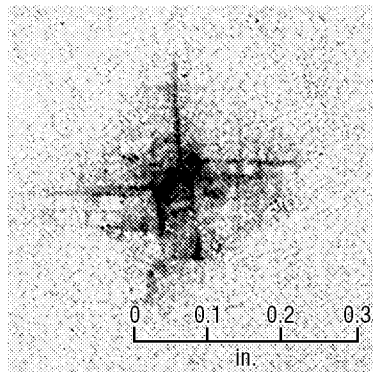
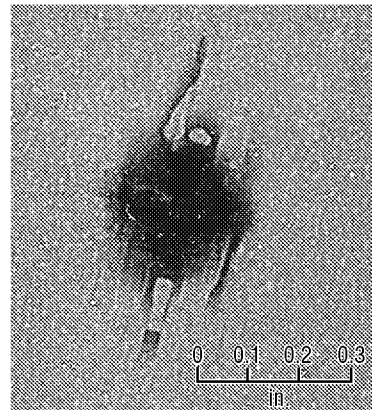
Figure 46 shows x rays of each type of resin system tested at the high-impact energy level. These x rays correspond to the visual observations of figures 44 and 45. The 977-6-resin system has noticeably less damage than the others. The Cycom 823 and RS-E3 systems appear as dark circles indicating massive damage directly under the impact zone. Delaminations emanating from the impact can be seen in the Cycom 823, RS-E3, and PEEK resin systems.

Figure 46. X rays of specimens impacted at 2.5 ft-lb.

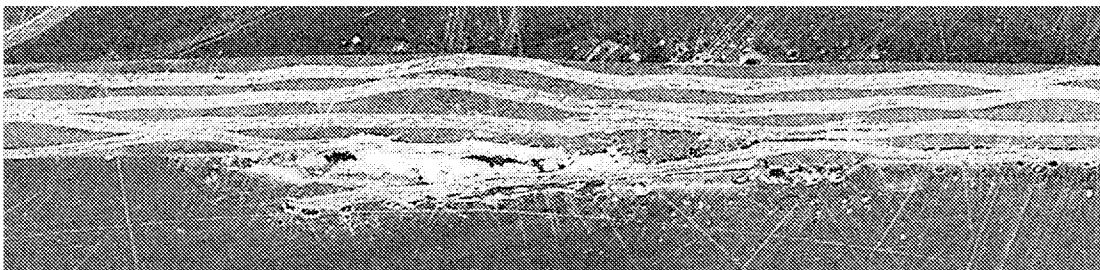
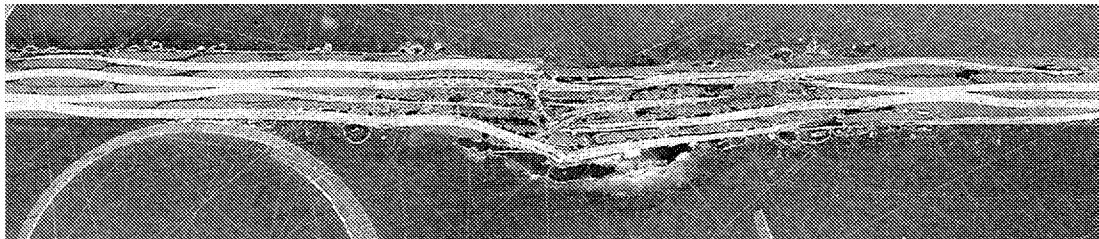
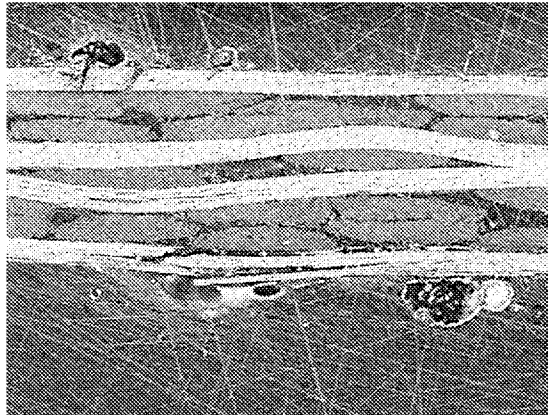
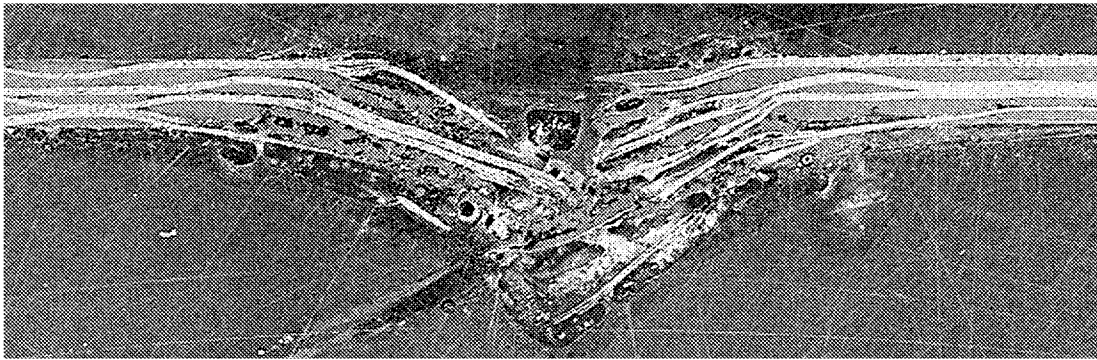
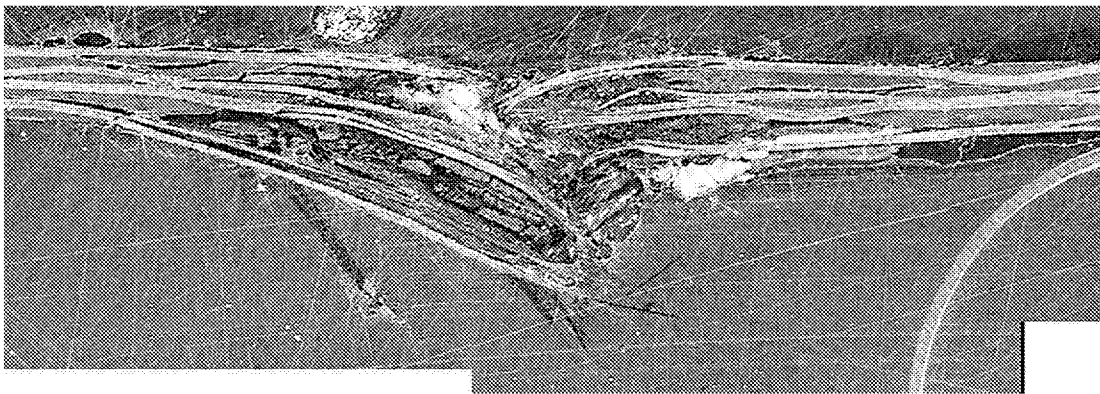
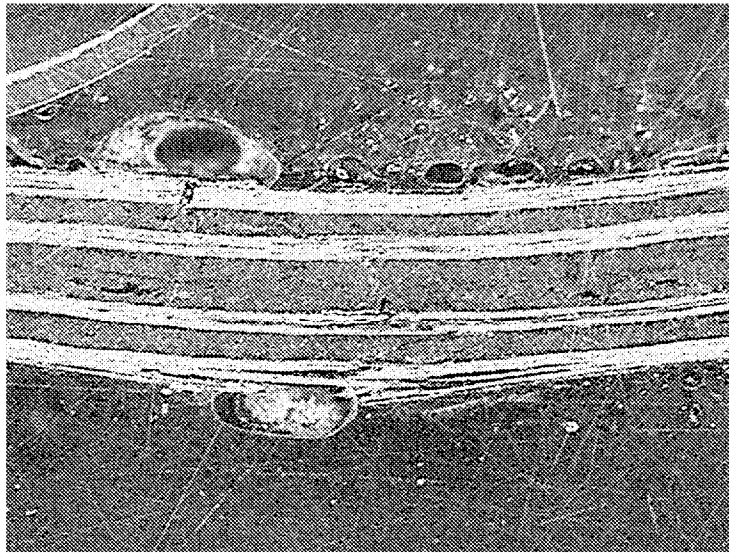
Figures 47 show photomicrographs of the cross section of each type of resin system tested at the high-impact energy level. The 977-6 and PEEK resins appear to have far less damage than the others tested. The Cycom 823 and RS-E3 resins show near penetration.

Figure 47. Cross-sectional photomicrographs of specimens impacted at 2.5 ft-lb.

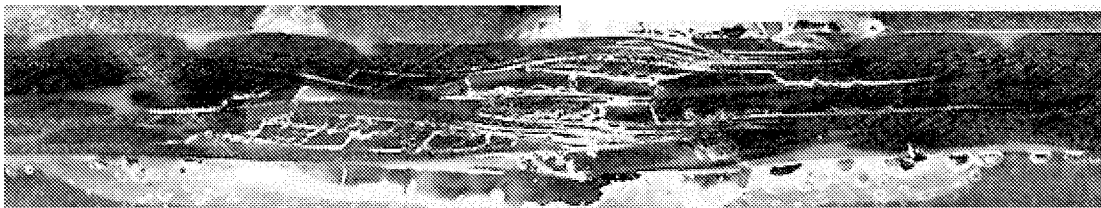
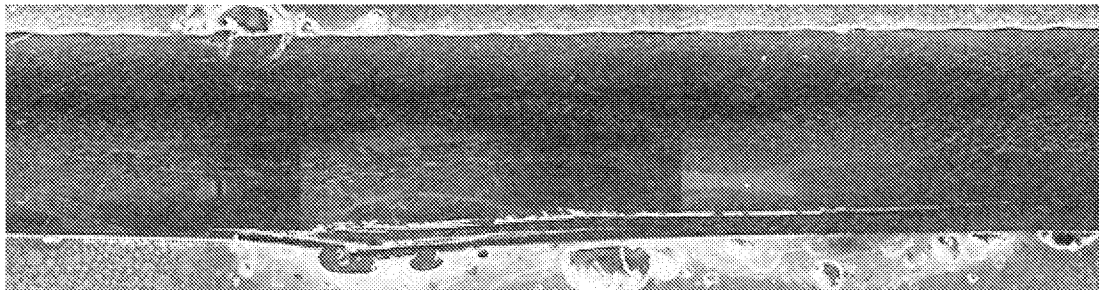
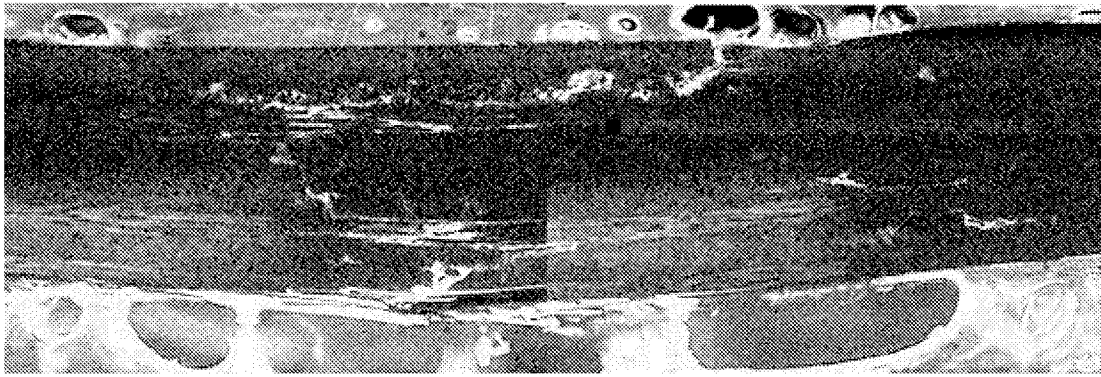
Figures 48 show fluorescent dye-enhanced photographs of these cross sections. This technique better shows the extent of damage present in the specimens. The 977-6 specimen only has two short delaminations near the outer plies and minor fiber breakage on the top ply. The plies in the center of the specimen appear to be completely damage free. The PEEK specimen shows good damage resistance; however, damage does exist throughout the thickness of the specimen. The severity of damage to the Cycom 823 and RS-E3 resin systems are even further highlighted by the fluorescent dye. The PR 520 resin system is seen to have delamination and matrix cracking within all plies although the photograph in figure 47 does not clearly show this and is a good argument for using a fluorescent dye penetrant even on samples where damage is readily visible.

Figure 48. Cross-sectional photomicrographs of specimens impacted at 2.5 ft-lb, fluorescent dye enhanced.

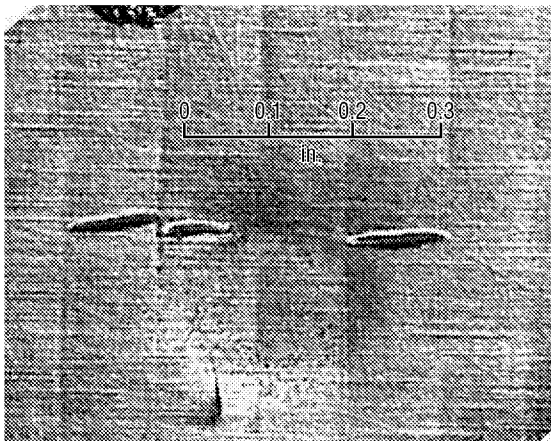
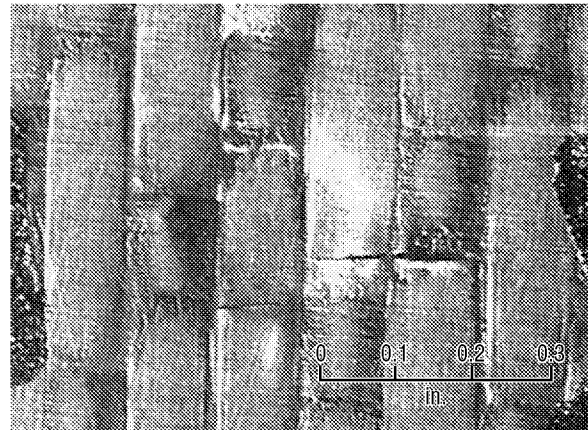
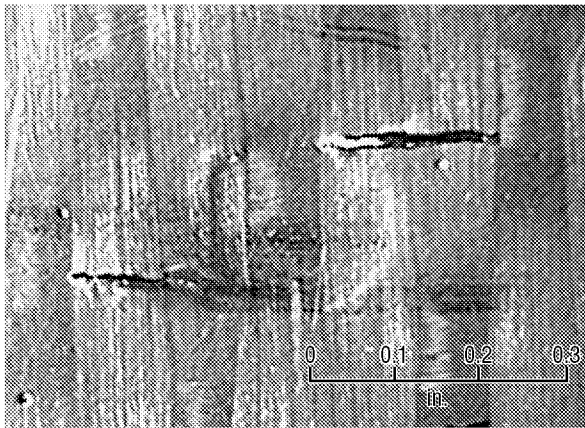
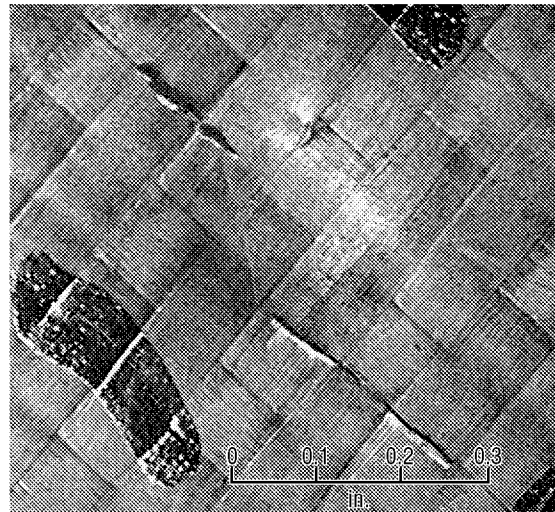
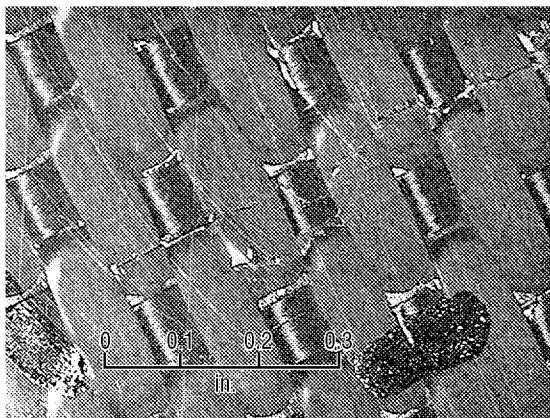
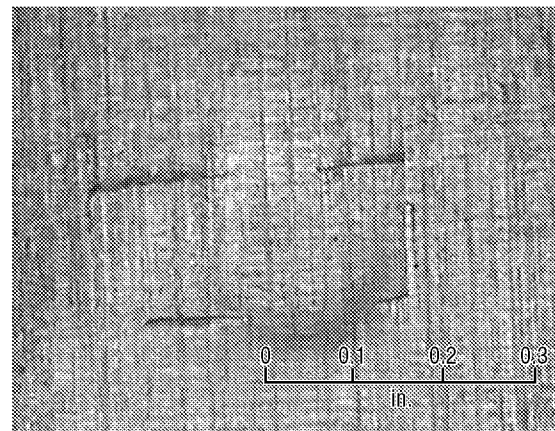
Figure 49 shows the impacted side of each specimen tested at the low (1.8 ft-lb) energy level. Fiber breakage is observed in most of the specimens in the form of short cracks emanating from the indentation on the surface. The RS-E3 resin has a long, fine crack that runs from the lower left to the upper right of the figure and very little indentation is observed. The mechanics behind these small cracks is unknown, but they have been noted in a previous study.⁷

Figure 49. Typical damage to impacted side of specimens at 1.8 ft-lb.

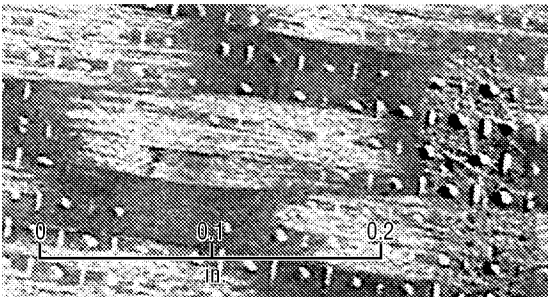
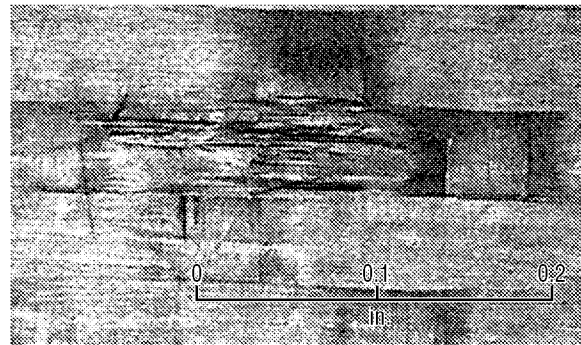
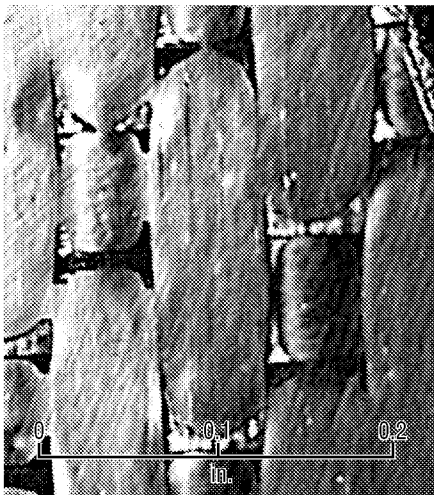
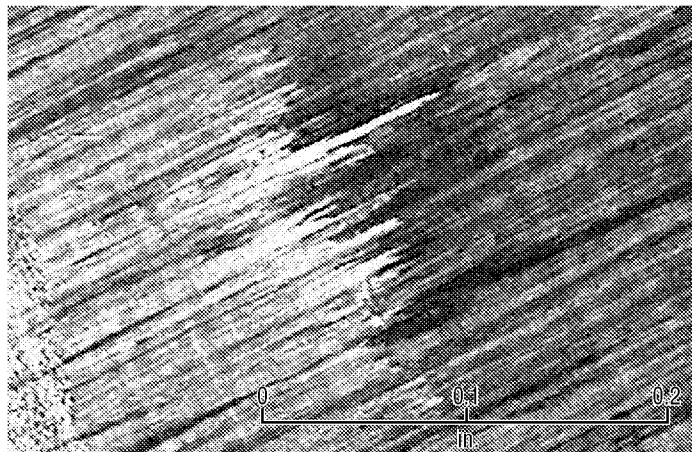
Figure 50 shows the back (nonimpacted) side of each type of specimen tested at the low (1.8 ft-lb) energy level. All samples show backface fiber breakage of varying magnitudes. The 977-6 and RS-E3 resin systems have barely noticeable backface damage. What little damage is present in these two systems is limited to less than two stitches, but never three or more. This type of damage could easily be overlooked during a routine inspection of a part.

Figure 50. Typical damage to nonimpacted side of specimens at 1.8 ft-lb.

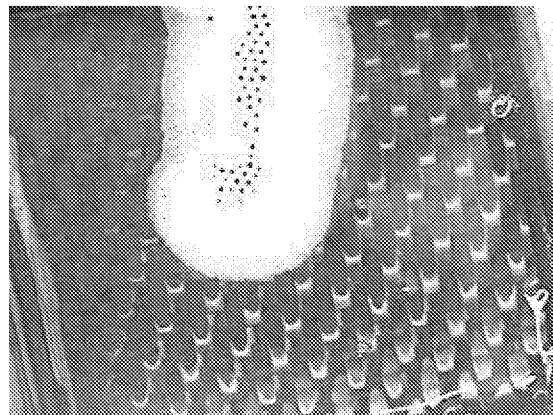
Figure 54. Specimen displaying a leak using a bubble-type leak detection fluid.
